SUSPENSION ROD TEARS FROM BOX BEAMS

CHANGE IN HYATT SKY WALK SUPPORTS

Critical design change linked to collapse Hyatt's sky walks

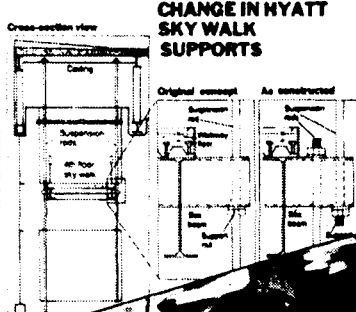
After examining the original design blueprints on file at City Hall and taking up photographs of the construction details, Luskha determined that the original design was flawed.

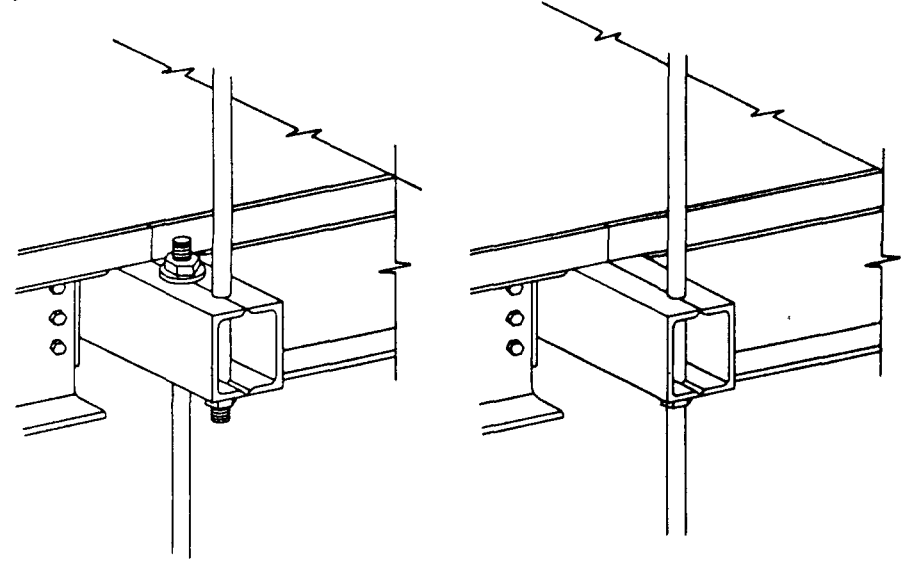
As Built

Original Detail

VII. The collapse of two suspended walkways in the Kansas City Hyatt Regency Hotel in 1981 killed over one hundred people and was the worst accident due to a structural failure in the history of the United States. There were many theories offered for the cause of the collapse, including the presence of too many people dancing on the walkways, recalling the collapse of early suspension bridges under the feet of marching soldiers. The real cause of the failure was quickly traced to a single change in the design of a support detail, apparently made to facilitate the erection of the skywalks. *The Kansas City Star*, which had hired an engineer as a consultant on the story, revealed the true cause within days of the accident in this Pulitzer Prize-winning story. Later tests at the National Bureau of Standards confirmed the cause to be in the detail.
